## Protein Matrix Study Report: Fast Food Restaurant

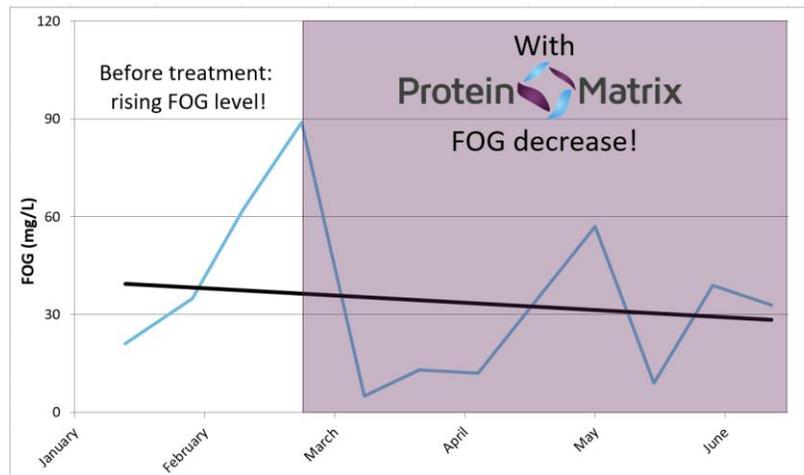
While FOG readings normally increase as grease accumulates in GGI (Jan-Mar), the use of Protein Matrix Eliminator at the FSE resulted in a decrease in effluent FOG (Mar-June).

In addition, the use of Eliminator led to a marked increase in the restaurant's compliance with effluent quality limits. Most importantly, the FOG readings consistently decreased when Protein Matrix was applied, never approaching the compliance limit of 100 mg/L (see figure below). In addition, less than one month after the Eliminator treatment concluded, we received word from Aqua America that the upstream waste treatment facility again noted elevated FOG concentrations in the waste stream from the restaurant.

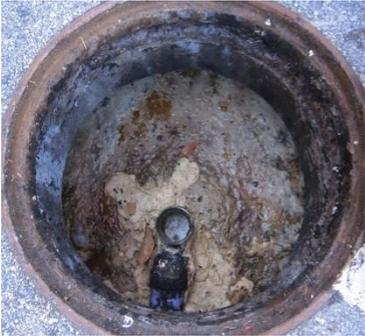
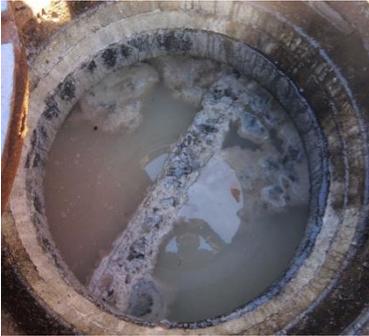
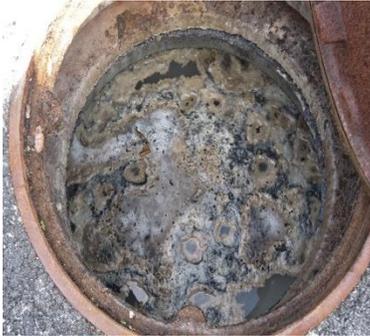
GGI 1 (Inlet)	GGI 1 (Outlet)	GGI 2 (Inlet)
One month of grease buildup

While one month of FOG accumulation from the restaurant resulted in solid grease buildup (top), three months of Protein Matrix Eliminator treatment led to clean interceptors containing only flowable liquid (bottom).

At the start of treatment, each interceptor was professionally cleaned by a grease hauling service and the dose of Protein Matrix Eliminator adjusted over time to determine the amount needed to maintain this level of cleanliness (see figures on following page). Three months after the GGI were pumped, the interceptors were opened and only liquid byproduct of the Protein Matrix Eliminator reaction with FOG was present - no buildup at all. This compelling result is most evident in the linked videos showing the stirring of the FOG-free liquid contents of each interceptor three months after the initial cleanout. While prior to the pilot, four cleaning events would have been needed during this period, it is evident that the GGI are as clean as when the study was initiated.
